The Cape Codder Condominium
Wastewater Disposal System:

System Monitoring and Assessment

Phase I – Initial Screening

THE SIPPEWISSETT ASSOCIATION
P.O. Box 501
FALMOUTH, MA 02541

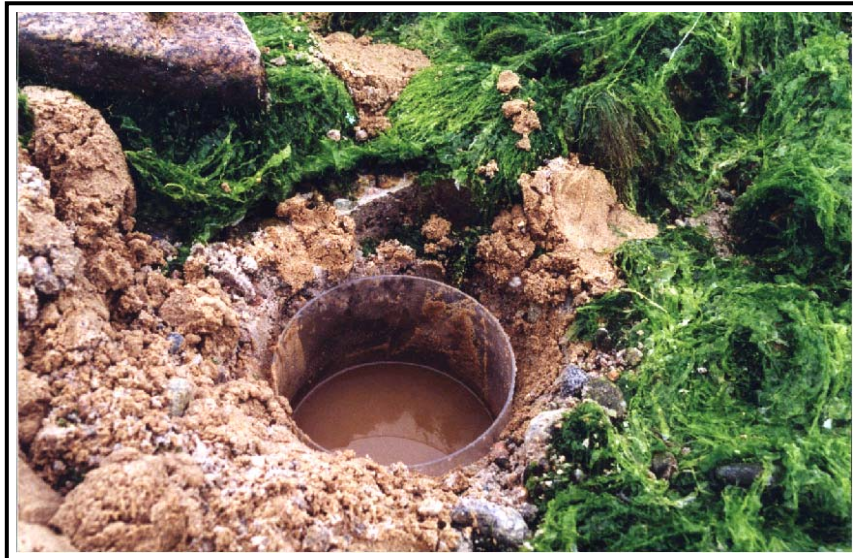
Figure 4. A temporary sampling well used to collect intertidal groundwater samples for virus and nutrient analysis. The plastic well casing is 8.25 inches in diameter and 14 inches in length. Samples were collected using a plastic submersible electric pump placed in the well. The green seaweed is probably a species of *Enteromorpha*.

For groundwater samples, short temporary wells were emplaced in the intertidal zone at Gunning Point Beach (Fig. 4) and water was collected using a small electrical pump. Before sampling the well was pumped down several times until clear groundwater flowed upward through the bottom sediment. Sterile water sample "cubitainers" and vinyl hose were provided by Analytical Services, Inc., Williston, Vermont, the company providing virus analyses. The electric pump had been cleaned and flushed with 5% calcium hypochlorite and rinsed with tap water and natural ground water for several minutes before catching samples. Samples for virus analysis were held in darkness between 0°-8 °C and delivered by courier to the laboratory in New Hampshire actually conducting the analysis, within the prescribed 24-hour time limit.

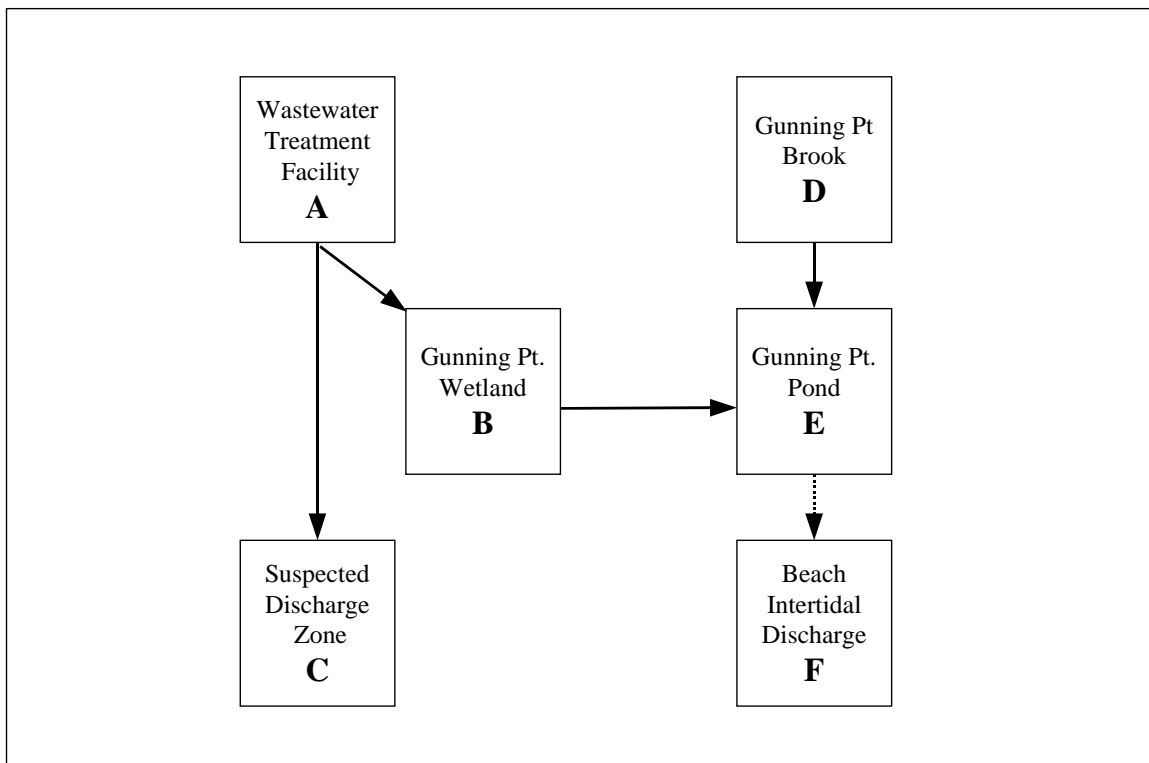
Figure 5. Materials flux pathways based in part on the chemical composition of water and groundwater samples from the vicinity of Hamlin Point, Falmouth, MA.

Chemical results reported here suggest water discharging at the intertidal zone characterized by intensive algal growth is significantly enriched by wastewater. This is represented in Fig. 5 by pathway A-C. Contamination of the wetland (pathway A-B) would also be consistent with our data. Flow from either the wetland or Gunning Point Pond to the algal/discharge area is not suggested by nitrogen, or total organic carbon data.

Materials flux from Gunning Point Brook to the Pond (D-E) is obvious, but flux from the Pond to the wetland is not suggested by nutrient data. Drainage through the beach is likely (E-F) but based upon salinity of the beach porewater there this flux is restricted.
